September 11, 2019

Park and Tree Sampling and Tree Protection Plan for Emergency Communications Facility in Cooks Butte Park

Appendix # 5

Area of Disturbance, Map of RC and RP Protection Area

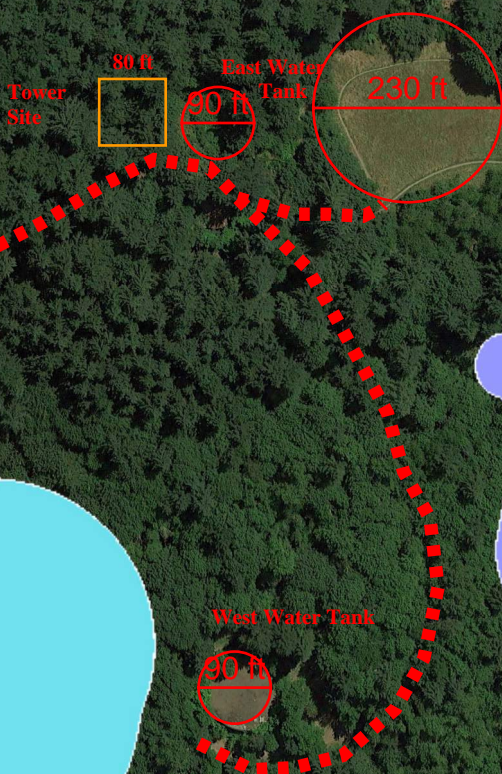
Cooks Butte Park is 42 acres. 12 acres has been designated as RP zone for stream corridors leaving 30 acres as the RC district. The area footprints of the developed areas are as follows:

Total area developed/open area or to be developed = 2.03 acres, 6.76% of the 30 acres of the RC area.

This allows 93.24 % of the RC to be designated as the RC Protection Area which easily exceeds the required protection of at least 85% of the existing RC district area.

The RC Protection Area will be the entire park minus the area of the existing RP Zones and where the communications tower, two water reservoir tanks, access road and the open meadow are located.
